Buildings from natural stones, erected by the Inca: secrets and technologies – a question of religion and faith?

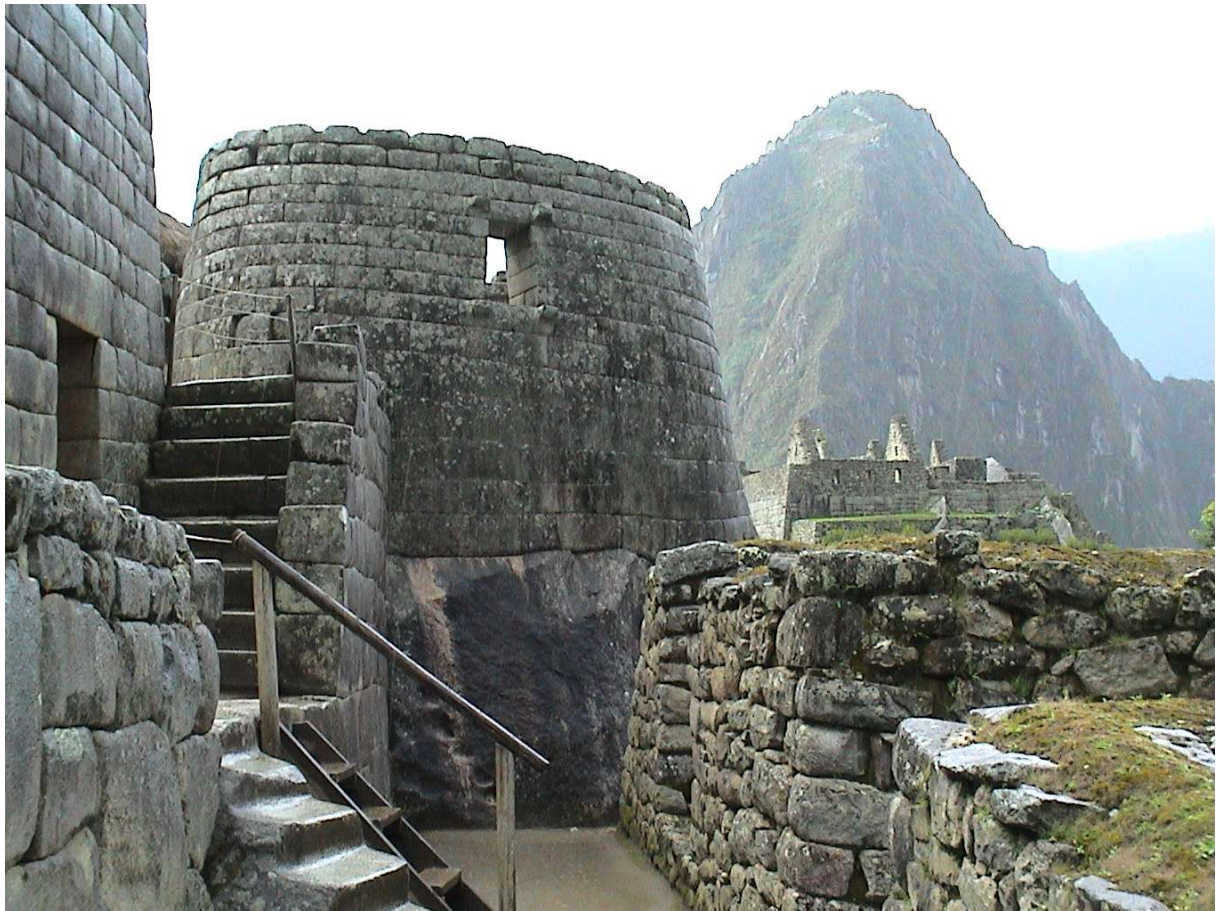
1 Buildings and temples have been erected in Machu Picchu, as you can see here in the case of the "Sun Temple", on stones created by Mother Nature.

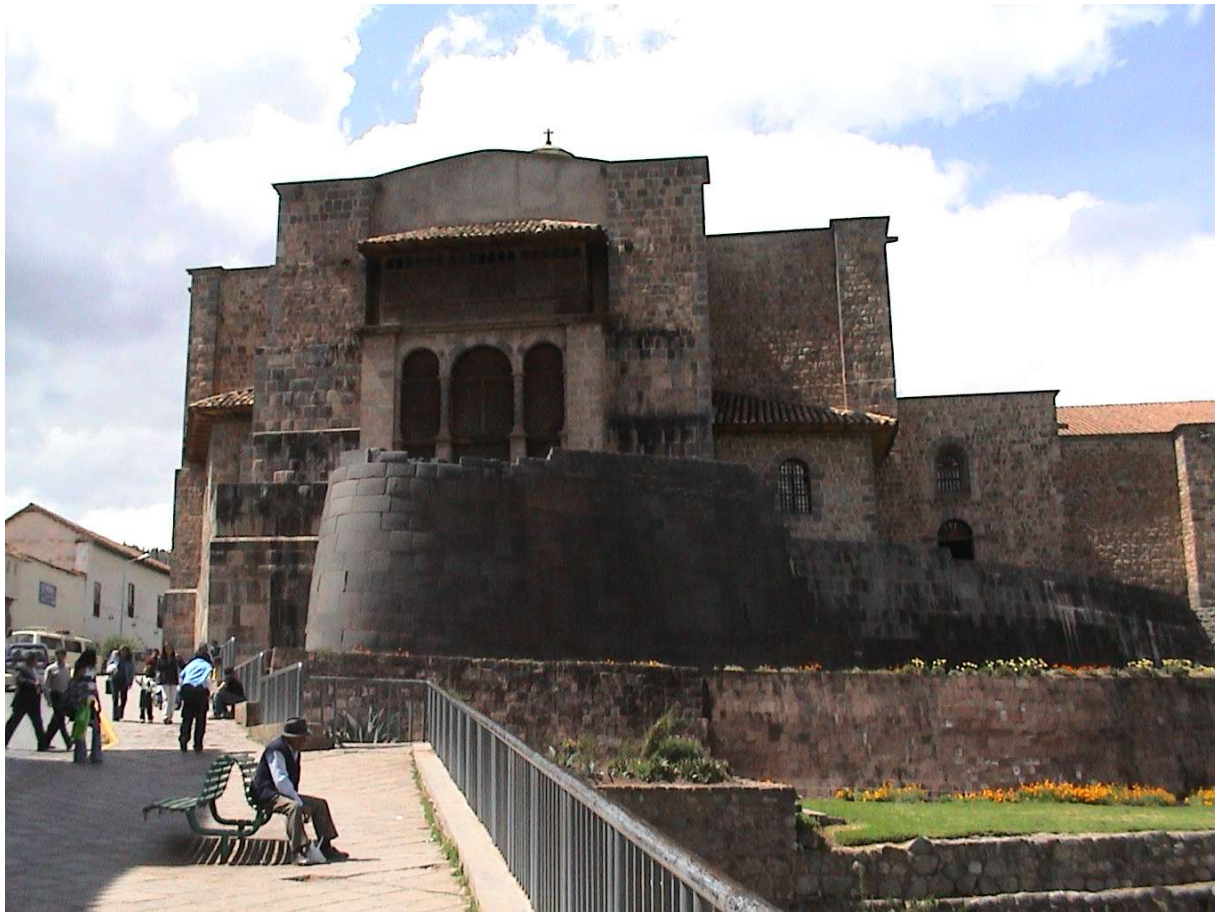
2 Sun Temple of the Inca Koricancha in Cuzco which can be recognized by the original darker natural stones that you can see in the centre of the picture. On the foundations of this temple, the church of Santo Domingo was erected.

stones have been destroyed in order to erect new Christian buildings. In many cases, the churches have been erected over demolished Inca buildings which highlight the big contrast between the unique technologies of the construction of walls without gaps of the Inca people and the walls with wide mortar joints constructed above these Inca walls by the Christians, which have a disdainful effect in comparison with the Inca buildings. This catches the eyes of the beholder in particular in the case of the ancient Sun Temple of the Inca "Koricancha" in Cuzco; the church of Santo Domingo has been erected on the foundations of this temple.

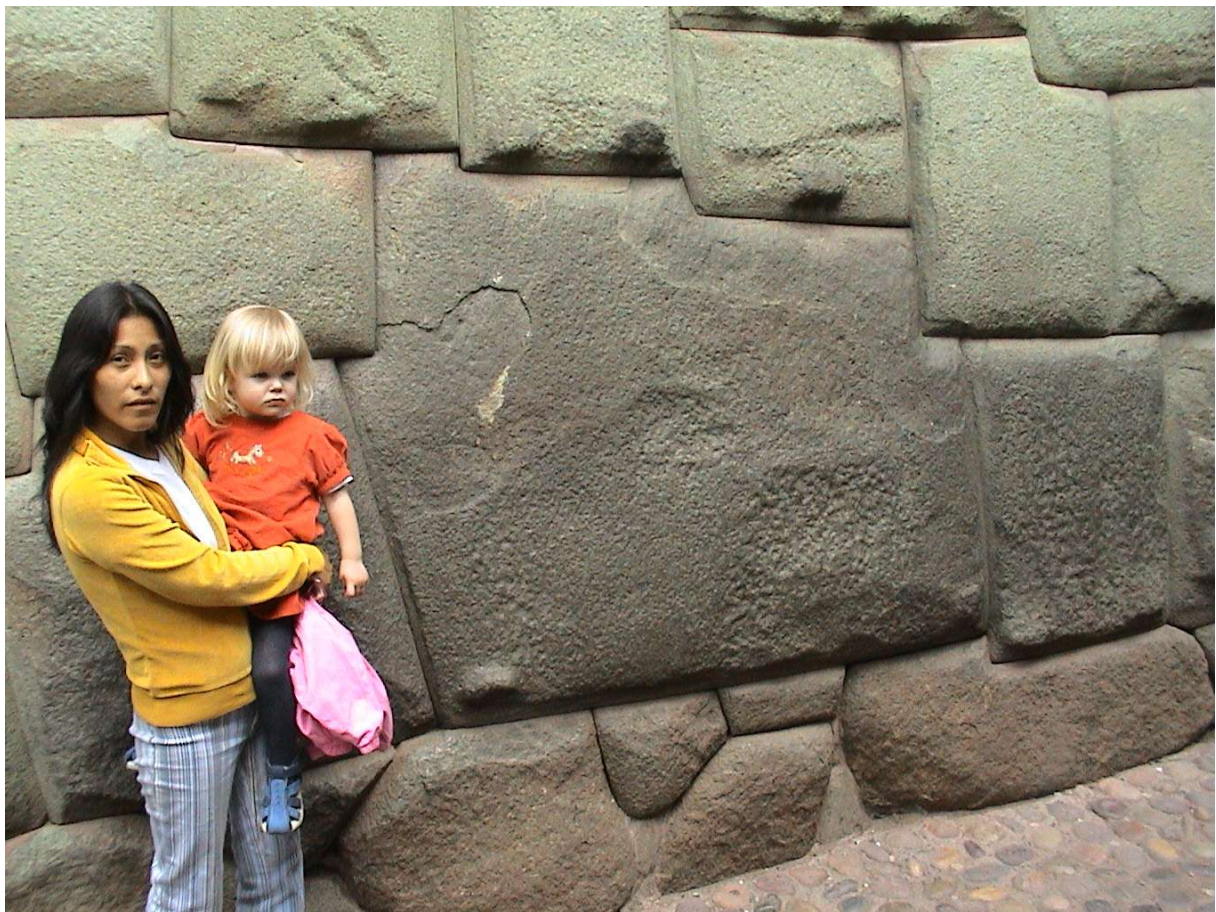
3 The most famous stone of all is certainly the stone with the 12 edges in the foundations of the former palace of the Inca Roca and of the current palace of the archbishop in Cuzco.

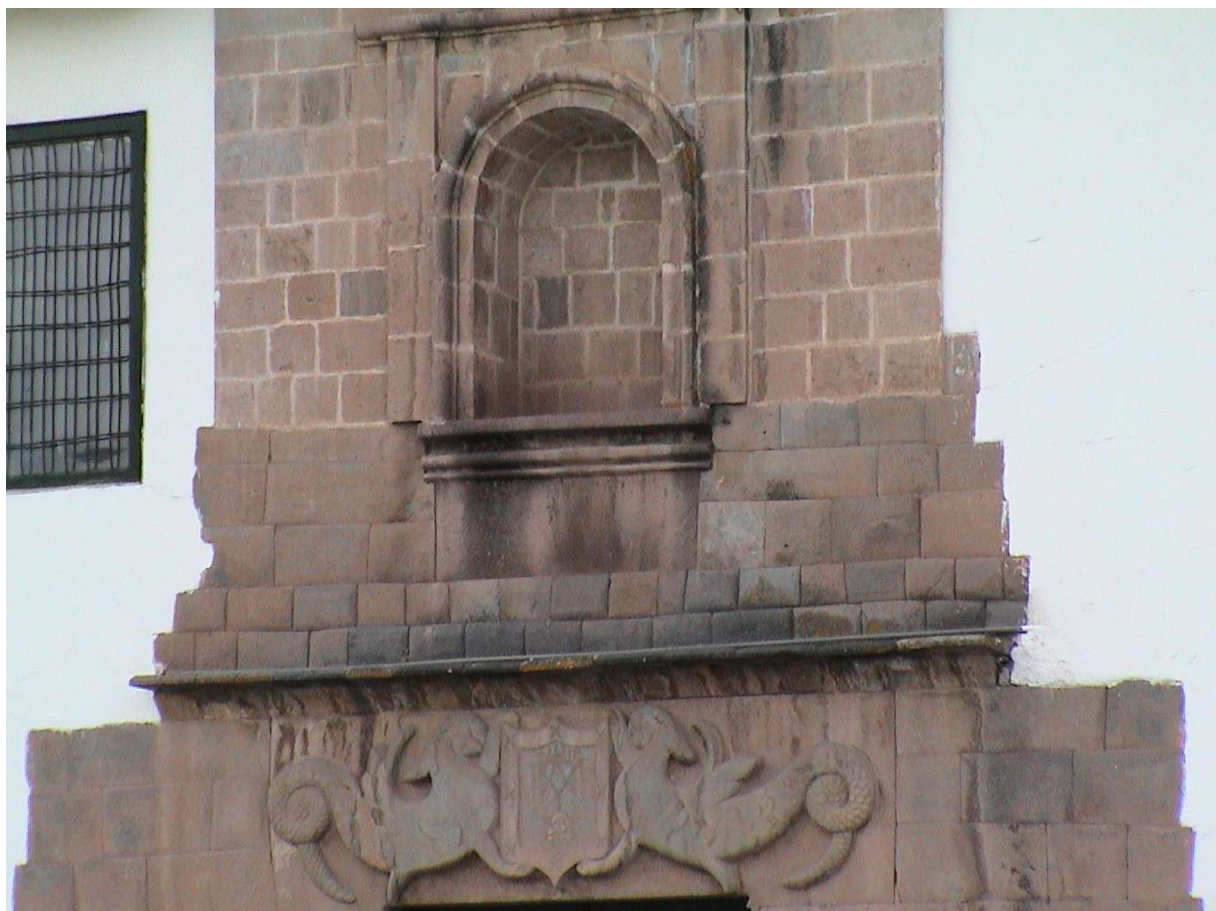
4 Different walls: the lower part in Inca style, the upper part in the style of the Spanish conquerors. Which one has the better optic effect?

These dimension stone walls would not correspond to our technical regulations as in accordance with the Standard DIN 18332 – Works with dimension stones – the joints of massive pieces, broad stones and faced walls have to have a width of at least 10 mm. If one looks at the state of maintenance of dimension stone walls which have been constructed in accordance with this Standard after some years, and if one compares them to the walls without joints of the Inca, which are approximately 500 years old, then one can't find really many arguments against natural stone walls without joints. Even temperature oscillations are much higher in the Andean regions than in our latitudes and can't serve at all as an argument for a caulking of natural stone walls with wide joints. Other aspects are the optical effect and the resistance against mechanical impacts.

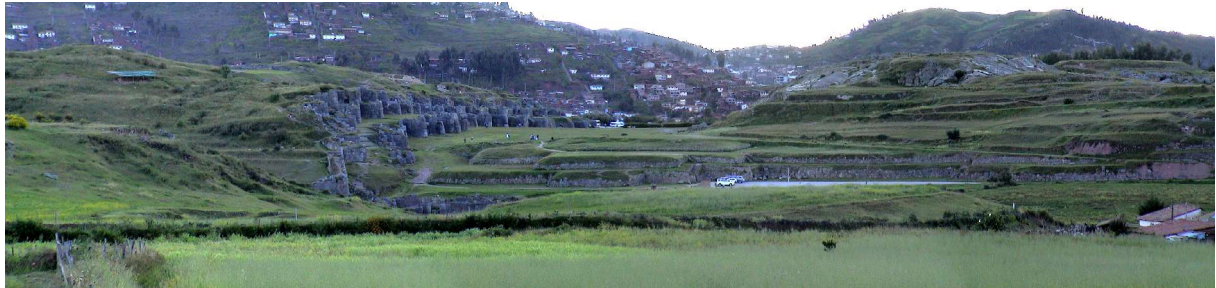
5 City of Sacsayhuaman, seen from the east (photos of the author)

The photo above shows an overview over the region of Sacsayhuaman from the east. At the left-hand side there is outcropping limestone. From the distance, the image, intensified by the walls, of a possible slope excavation becomes clear. Shortly before the ascension of the diorite hill and at the right edge of the photo, there is outcropping limestone again, the latter at the same altitude level as at the left edge of the photo. The here existing and clearly visible mass deficit can be explained by the excavation of limestone, whereby this zone might have been backfilled in parts by the Spaniards.

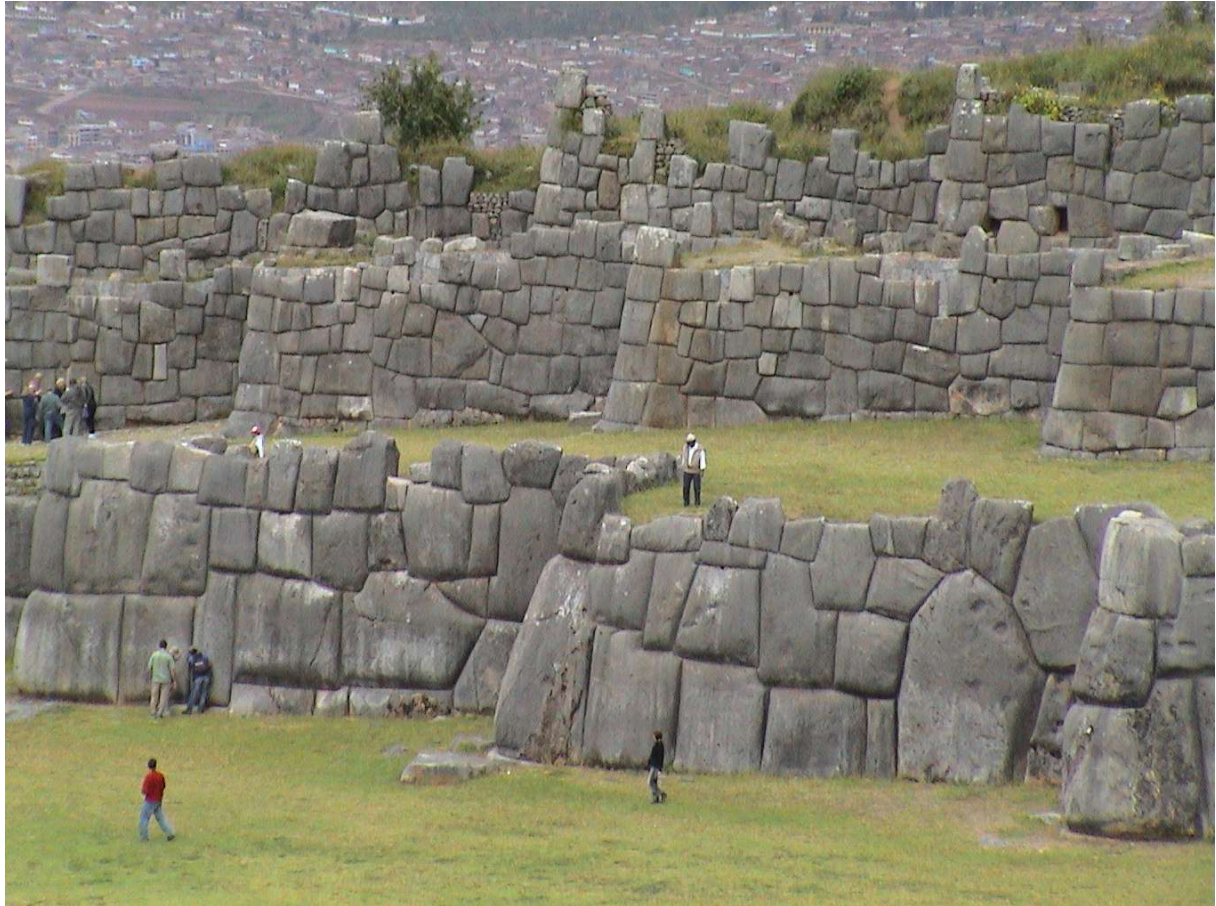
6 Sacsayhuaman is famous for three walls from giant stones, erected one above the other; the dimensions of the blocks diminish with the height.

If the stones had their origin at other places, the Inca, or the sometimes speculated extraterrestrial beings, could easily have done the effort to put huge blocks above; they would have had to overcome the very steep mountain from Cuzco to Sacsayhuaman anyway. However, if one looks at the different rows of natural stones, it catches one's eyes that the size of the blocks diminishes towards the top.
